UNIVERSITY OF THE AEGEAN
SCHOOL OF ENGINEERING
Department of Financial and Management Engineering

DOCTORAL THESIS

INVESTIGATION OF CORROSION-INDUCED
DEGRADATION OF AERONAUTICAL ALUMINUM-
COPPER AND ALUMINUM-COPPER-LITHIUM ALLOYS

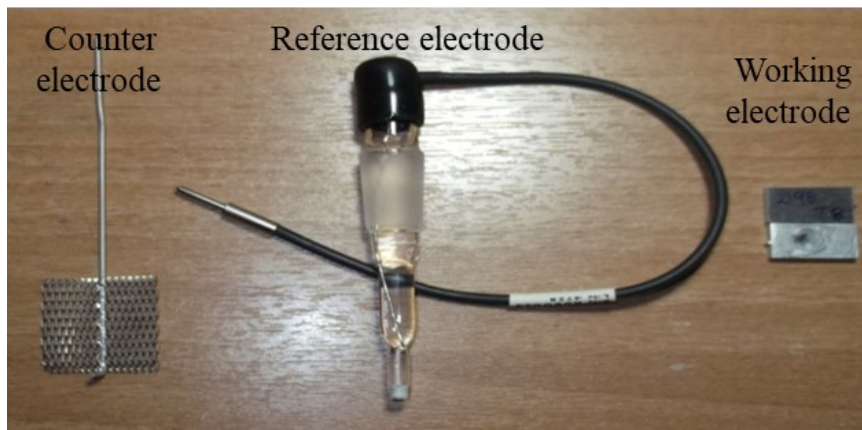
Picture 2-3: Electrodes used for the electrochemical impedance spectroscopy (EIS) measurements.

The corrosion behaviour of the investigated aluminium alloys was assessed by electrochemical impedance spectroscopy (EIS) tests, which were carried out using a PalmSens® potentiostat at 25 ± 1 °C. The experiments were carried out in naturally aerated 3.5 wt. % NaCl solution at room temperature (25 ± 2) °C since the in-service obtained corrosion damage correlates well to the one caused by this solution [88]. However, for the case of AA2198-T8, the Harrison's solution [94] was also used in EIS tests since it better simulates the corrosion in industrial atmospheres – which are more aggressive due to the presence of soot, fly ash and sulfur compounds – that cause coating consumption. A typical three electrodes cell system that was composed of a platinum electrode as counter electrode, a silver chloride electrode Ag/AgCl as reference electrode and the small rectangular specimens (10 mm * 20 mm) of the investigated aluminium alloys as working electrodes was used, shown in [Picture 2-3](#). A surface area of 0.5 cm^2 of the working electrode was exposed to the electrolyte. The voltage perturbation range used in the EIS measurements was 10 mV (rms), and the acquisition rate was 10 points per decade in a frequency range from 10^5 Hz down to 0.01 Hz. The measurements were repeated at fixed intervals of 0 (after 5 min immersion), 1, 3, 6, 12, 24, and 48 hours of immersion time. Each test was performed at least three times to evaluate the reproducibility of the results. The obtained data were fitted employing a PStrace5® analysis software. The set-up of the experiments is depicted in [Picture 2-4](#).

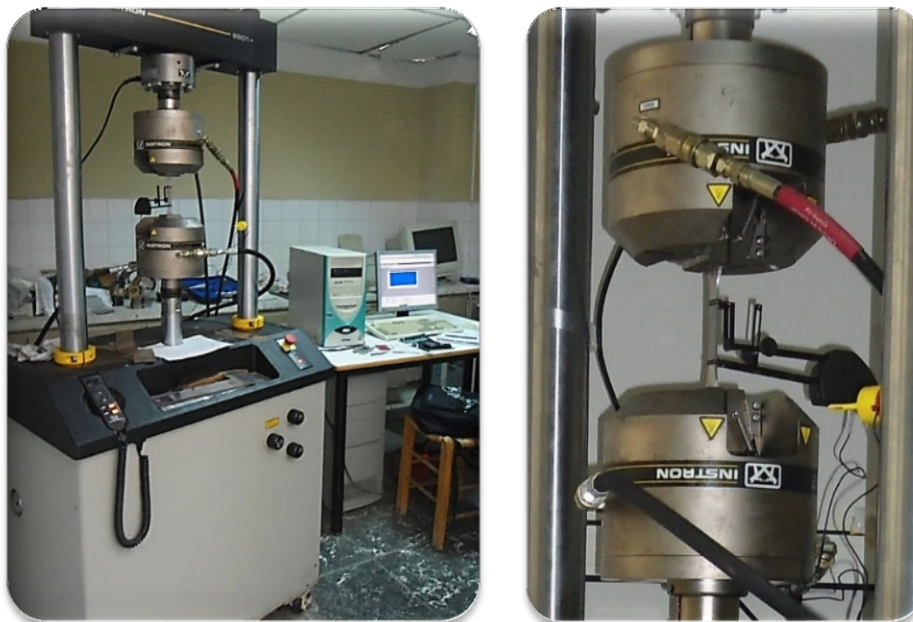
Picture 2-7: Experimental set-up of tensile testing.

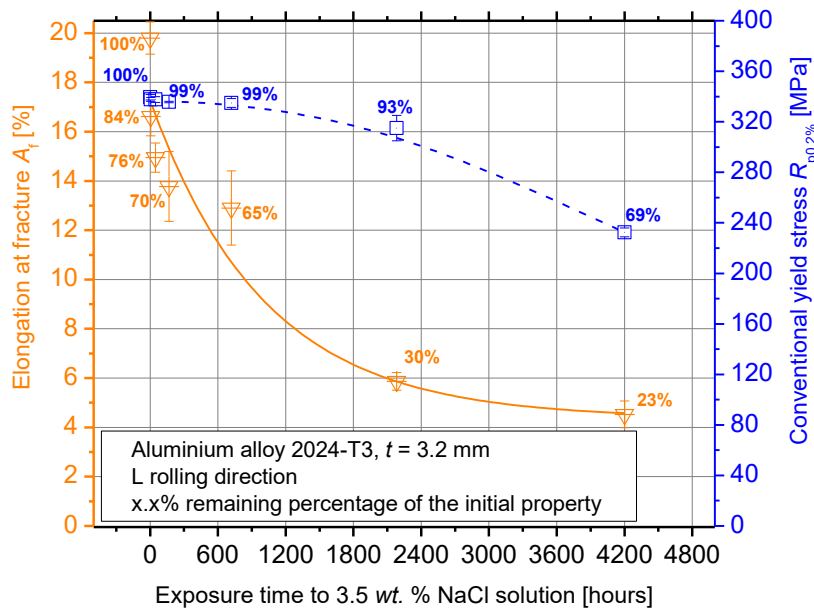
Figure 2-7: Experimental results of mechanical properties of AA2024-T3 after exposure to 3.5 wt. % NaCl solution for different exposure times.

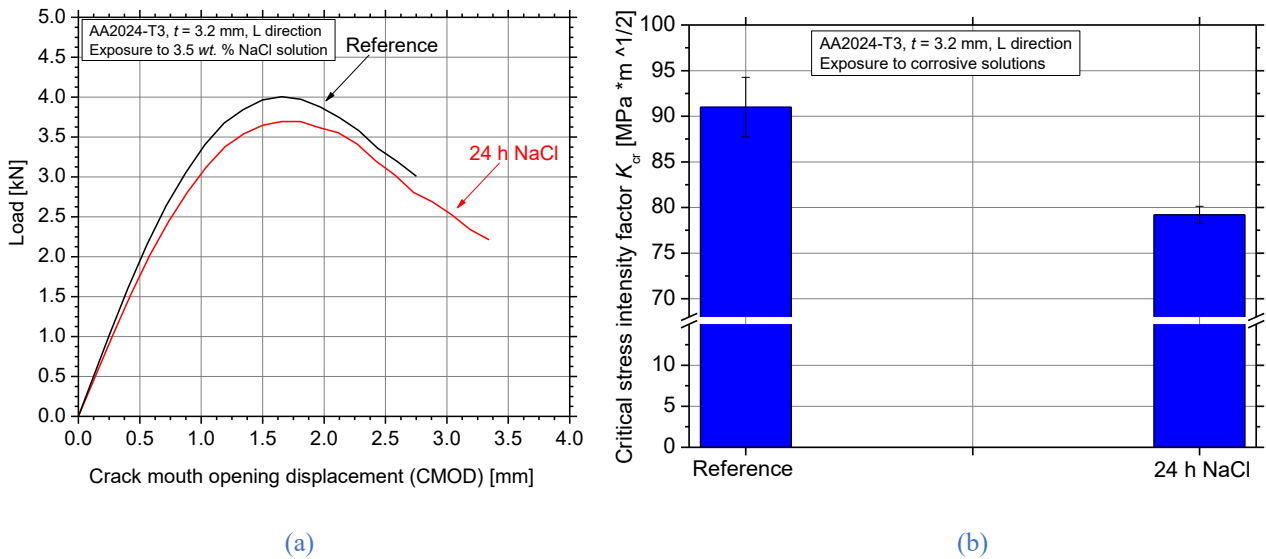
Figure 2-10: (a) Load–crack mouth opening displacement (CMOD) curves and (b) evaluated critical stress intensity factor (K_{cr}) values of AA2024-T3 specimens after exposure to 3.5 wt. % NaCl corrosive solution.

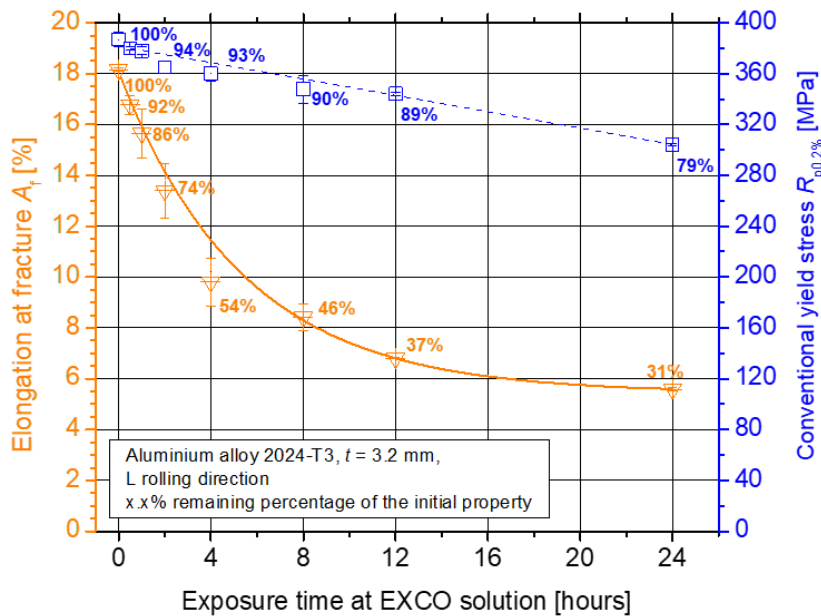
Figure 2-14: Experimental results of mechanical properties of AA2024-T3 after exposure to EXCO solution for different exposure times.

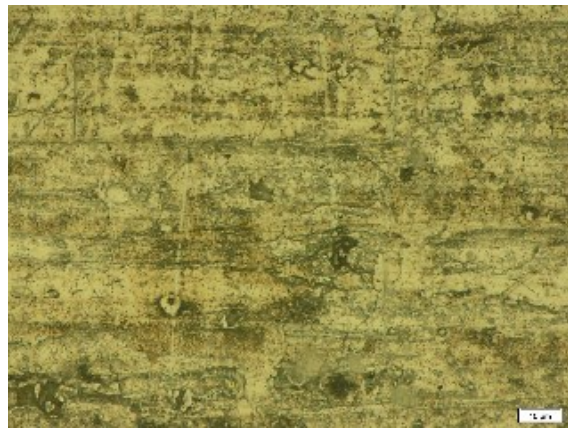
Figure 2-19: High magnification (1000x) optical micrograph of the C(T) (L-T) specimen surface after 2 h exposure to EXCO solution, showing no signs of significant pitting or intergranular corrosion.

the specimen surfaces after the exposure to EXCO solution revealed no visual signs of significant pitting nor intergranular corrosion (refer to Figure 2-19).

4 mm ahead of the extended primary crack front, no secondary cracks are observed. It is also important to note that the secondary cracks were not visible immediately after the exposure to the EXCO-solution (refer to [Figure 2-19](#)), but only formed after the crack-growth resistance testing, that is, after the loading of the specimens. Considering the plastic-zone size (r_y) calculated during the crack-growth resistance procedure (according to ASTM E561 specification [91]), it appears that the final calculated diameter of the plastically affected zone ($\approx 3.78 \pm 0.04$ mm) correlates well with the area in which secondary crack formation is observed. Furthermore, according to the scale in [Figure 2-24](#), the secondary cracks – indicated with the red arrow (b) – were measured through Image Analysis software and found to extend up to an approximate depth of 0.115 mm from the exposed surface. This corresponds well with the thickness of the intergranular fracture surface – labelled (D) in [Figure 2-22](#) – which was calculated to be 0.12 mm in depth. The comparability between the depth of the secondary cracks evident in the EXCO-exposed specimens and the thickness of the intergranular fracture surface indicates that the secondary cracks form due to some form of grain boundary embrittlement. Whether this is induced by hydrogen embrittlement (HEDE model), or by the formation of some intergranular compound (*e.g.*, AlH_3) during the exposure of the specimen, is yet to be determined. However, the cohesion strength of grain boundaries near the exposed surface is significantly reduced for the specimens exposed to EXCO solution.

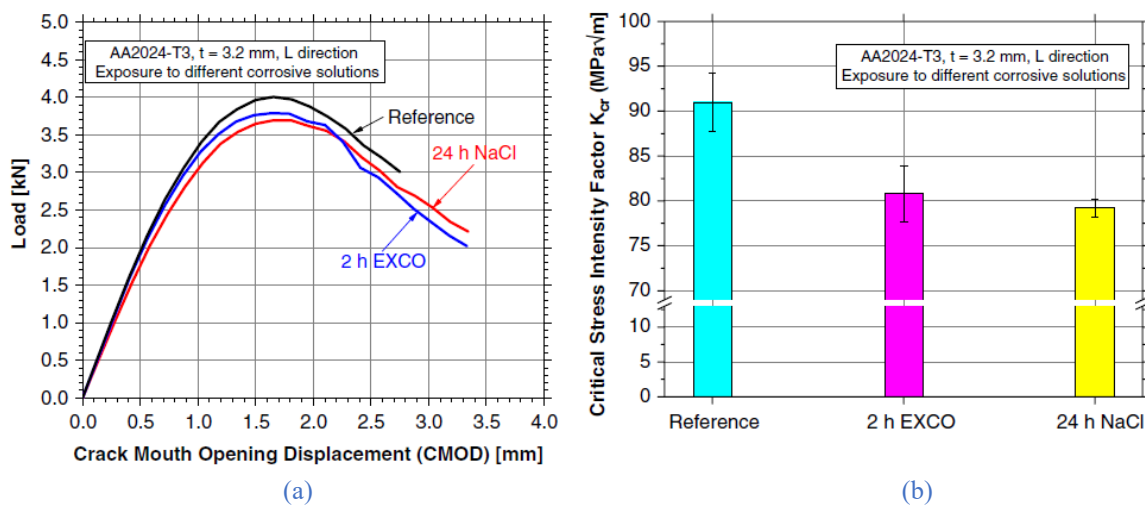
Figure 2-20: (a) Load–crack mouth opening displacement (CMOD) curves and (b) evaluated critical stress intensity factor (K_{cr}) values of AA2024-T3 specimens after prior exposure to different corrosive solutions.

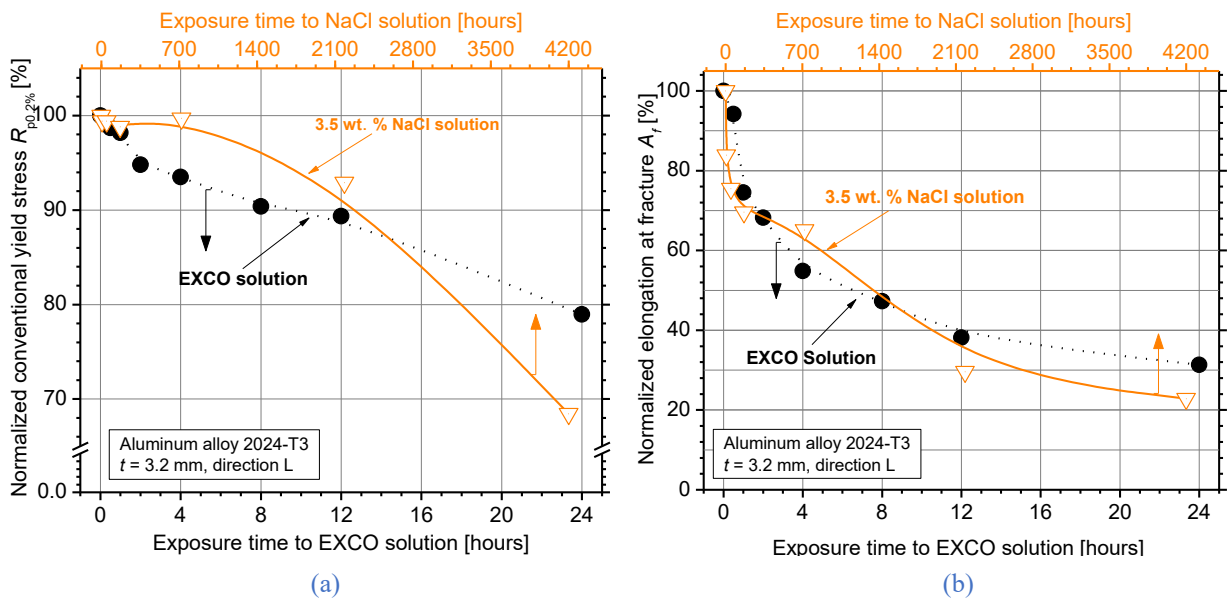
Figure 2-25: Normalized (a) conventional yield stress ($R_{p0.2\%}$) and (b) elongation at fracture (A_f) values of AA2024-T3 for the various exposure times to EXCO solution compared against 3.5 wt. % NaCl solution.

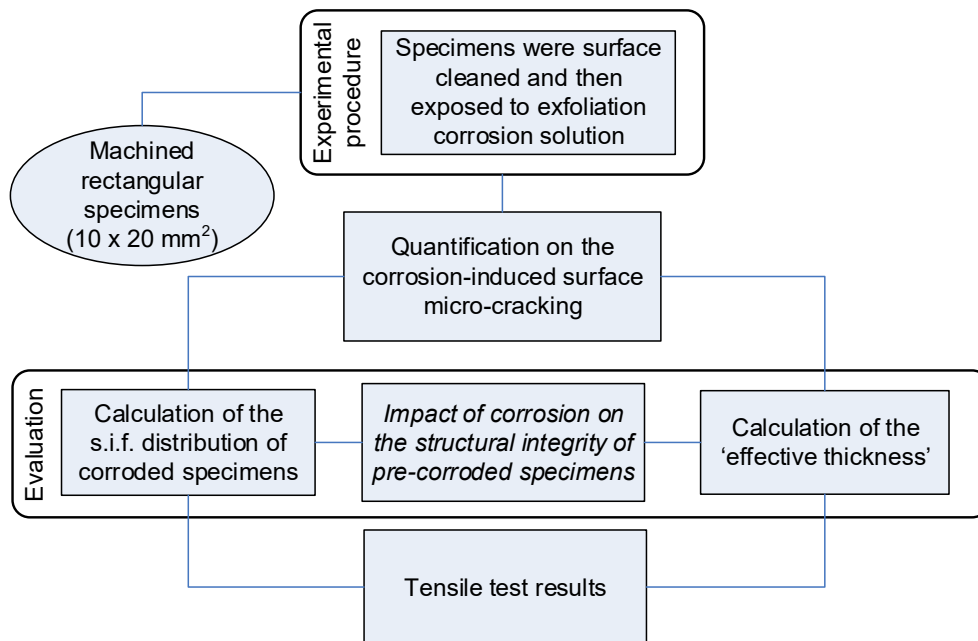
Figure 3-1: Flow chart of the experimental procedure for the effect of corrosion micro-cracking on ultra-thin (0.4 mm) AA2024-T3 specimens.

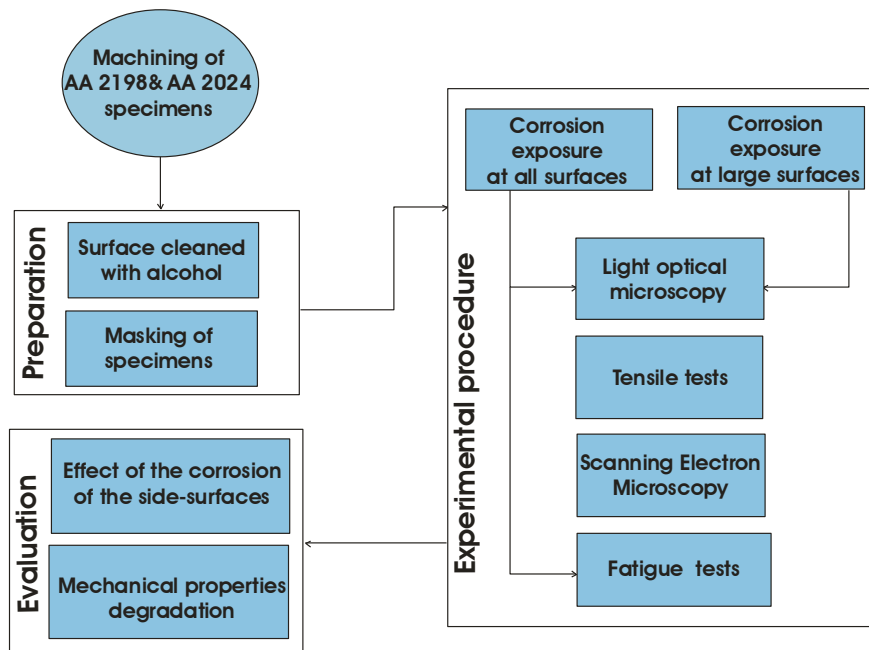
Figure 3-2: Flow chart of the experimental procedure for the effect of side-surfaces corrosion micro-cracking on AA2198-T351 specimens.

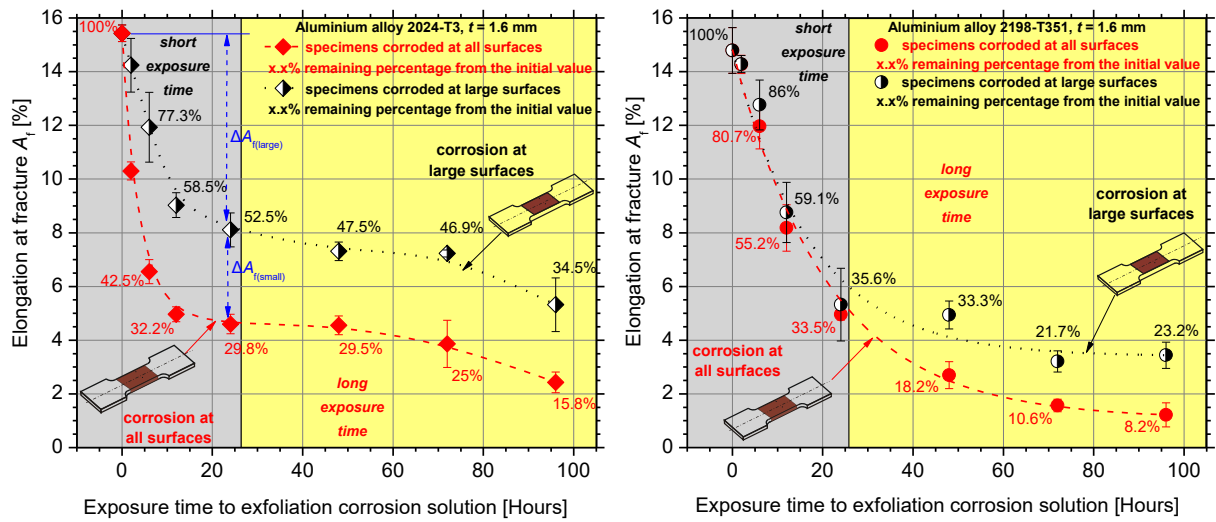
Figure 3-29: Comparison of elongation at fracture A_f of specimens corroded at all surfaces and specimens corroded at large surfaces for AA2024-T3 (left) and AA2198-T351 (right).
